Response to EPA General Notice of Potential Liability, Yosemite Creek Sediment Superfund Site, San Francisco County California

RWD Associates, LLC

**1205, 1301, 1375 and 1335-1339 Yosemite Avenue
1296, 1320, and 1340 Armstrong Avenue
San Francisco, California 94212**

January 10, 2014

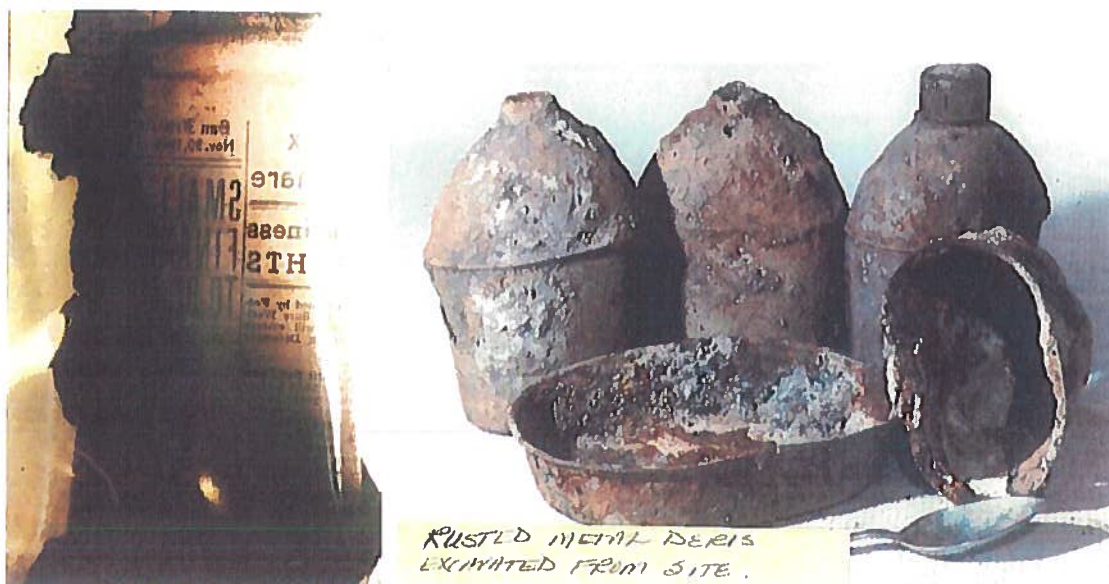
**Inset Figure 1: Wastes Recovered from
1986 YFOC Trench by City and County of San Francisco (Steve Mullinnix)**

Mr. Mullinnix also testified that newspapers from 1944 and 1945 were among the fill items. RWD provided Waterstone with photographic evidence of additional items found in the fill, in 1986, including:

(E&E, 1990). Steve Mullinnix's deposition transcript provides details of the YFOC sewer upgrade not previously reviewed by EPA or the PRP Group Attorney (Steve Mullinnix, 1993).⁶ Mr. Mullinnix's sworn testimony lists the materials he observed in the fill, adjacent to the Subject Property, in 1986:

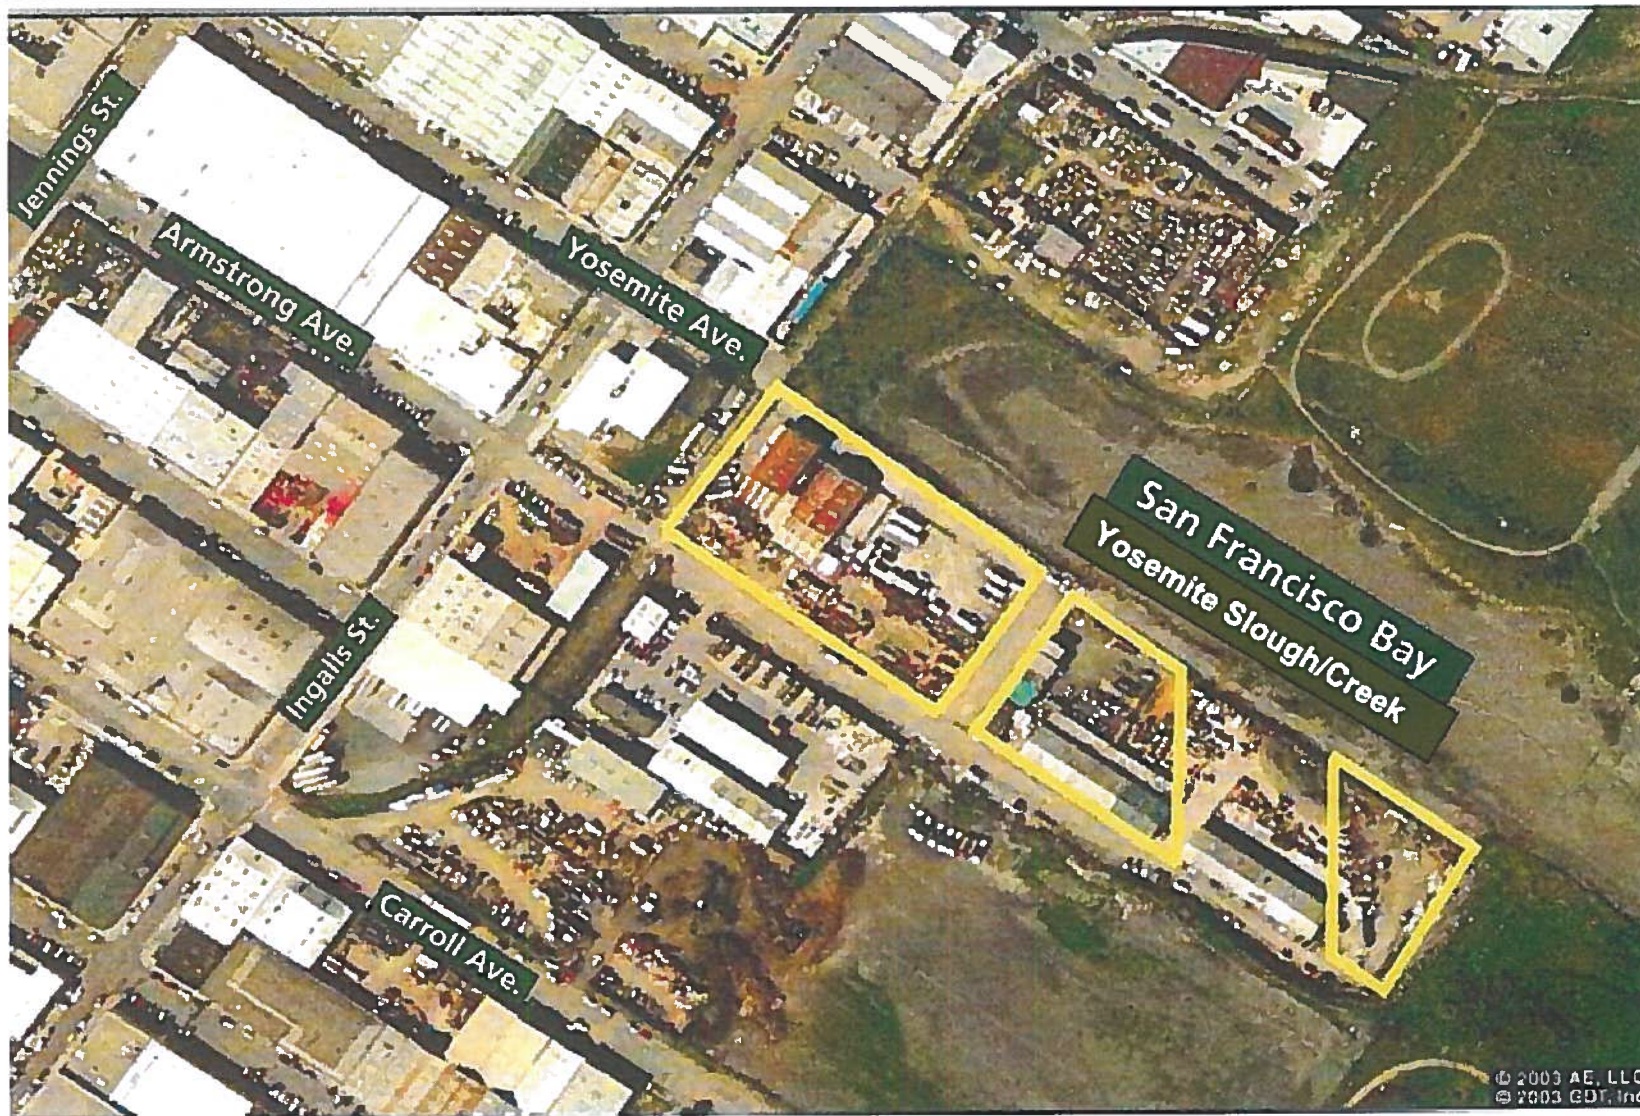
Figure 3
RWD Ownership
RWD Properties
San Francisco, CA

³ There is a portion of the eastern half of the Subject Property which is not owned by RWD (Figures 3 and 4). Julio Ricci leased this tract until 1998. The tract reverted back to the State of California in 1999. The State of California owns this 1.0 acre tract of land which is administered by the Port of San Francisco.

The RWD property¹ is 3.357 acres in size, and is located at 1205, 1301, 1375, and 1335-1339 Yosemite Avenue and 1296, 1320, and 1340 Armstrong Avenue, San Francisco, California 94212 (Subject Property).² The Subject Property is located in the northwestern portion of San Francisco Bay (Bay), south of downtown San Francisco (Figure 1). Northeast of the Subject Property is the rocky peninsula known as Hunters Point that extends into the Bay (Figures 1 and 2). Figures 3 and 4 show the Subject Property's boundaries.³

Inset Figure 6 (below) is an aerial photo taken on September 1, 1956 (obtained from the National Archives). This 1956 photo shows the Subject Property developed with some of the existing structures and facilities. The warehouse buildings currently located on the Subject Property (see Figure 3), are present on the southern side of the property, adjacent to Armstrong Avenue. Inset Figure 7 shows multiple rows of containerized and/or palletized material in a paved yard north of the buildings on the Subject Property. The properties south of the Subject Property (currently used as stadium overflow parking), and the property southwest of the Subject Property (currently used for container and trailer storage), were also filled-in by 1956. Photography for the proposed Candlestick Park development, dated May 18, 1958 (not shown), reveal the same conditions observed in the 1956 photography. Based on the 1958 photo, it appears that no additional fill placement occurred on the Subject Property margins after September 1956. RK Lumber took possession of the Subject Property in 1954, a year or two prior to Inset Figure 7 (below). Development seen on this photograph is the early use of the Subject Property by the lumber yard operated by RK Lumber.

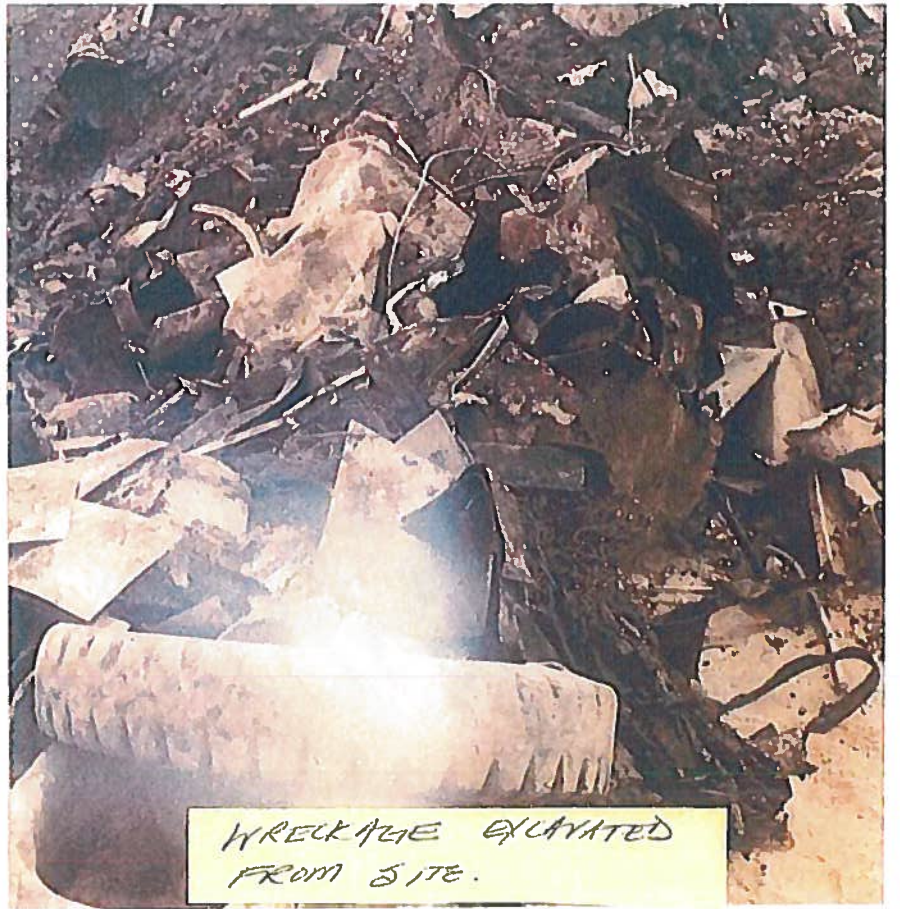
WRECK PIE EXCAVATED
FROM SITE.

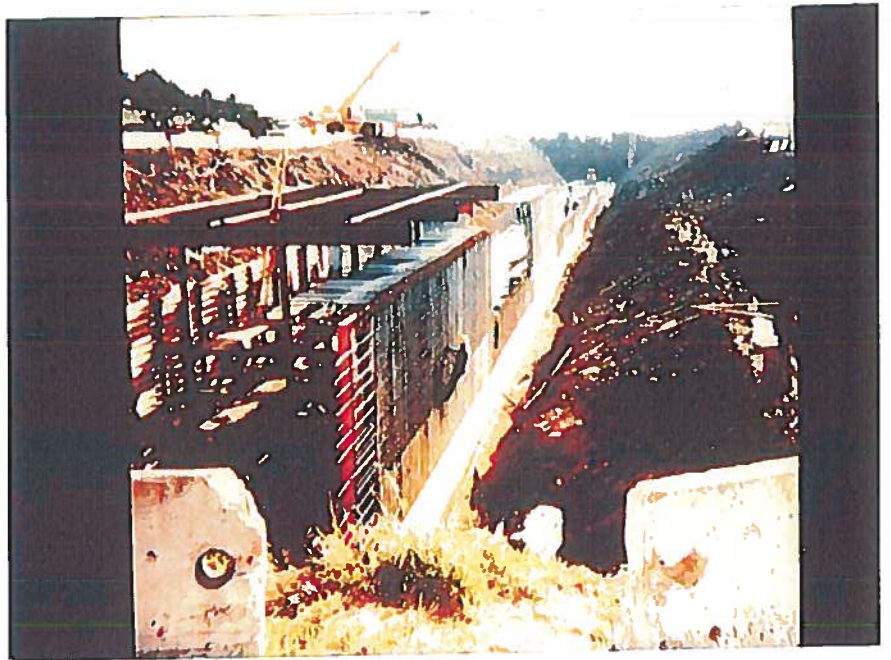
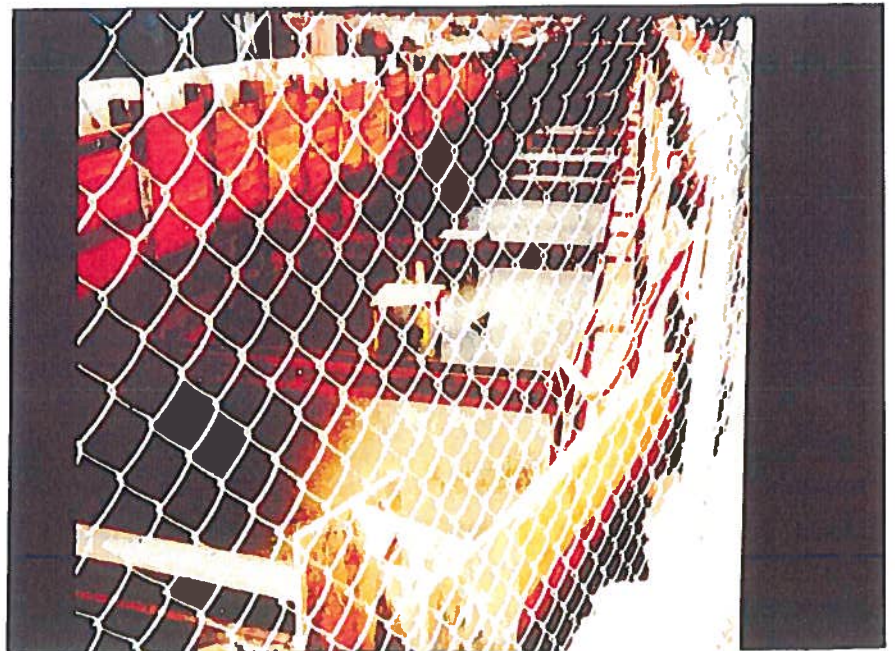
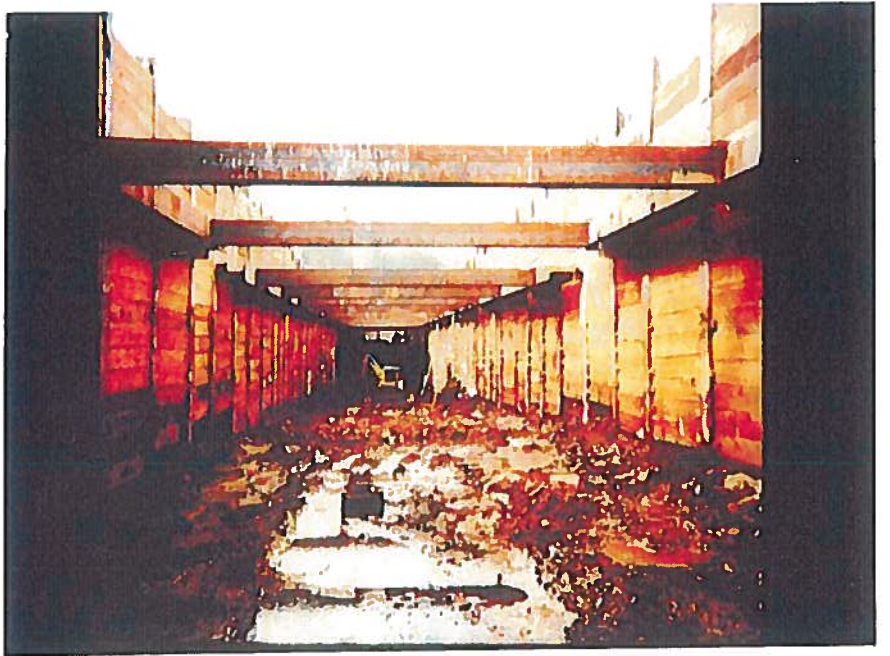
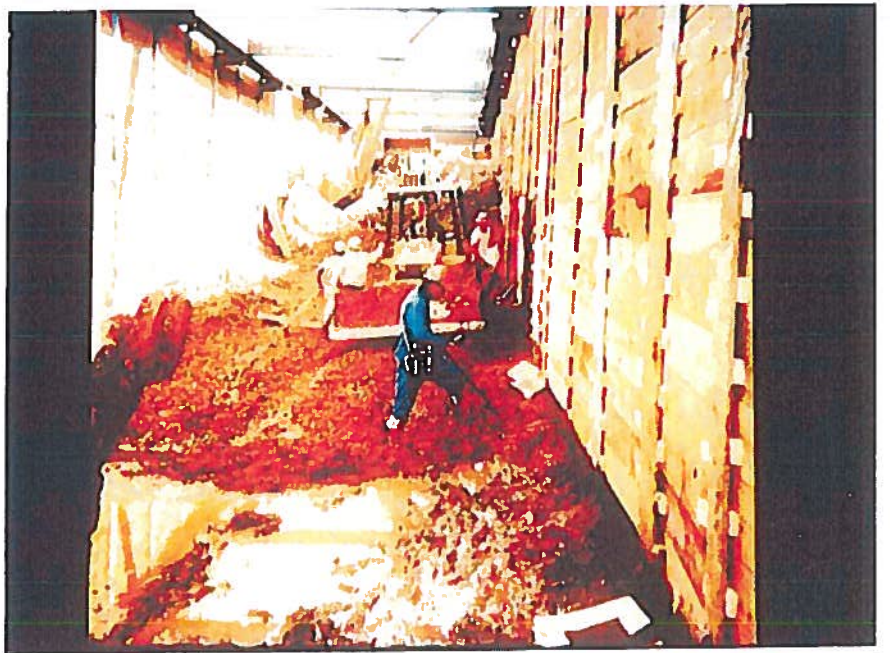
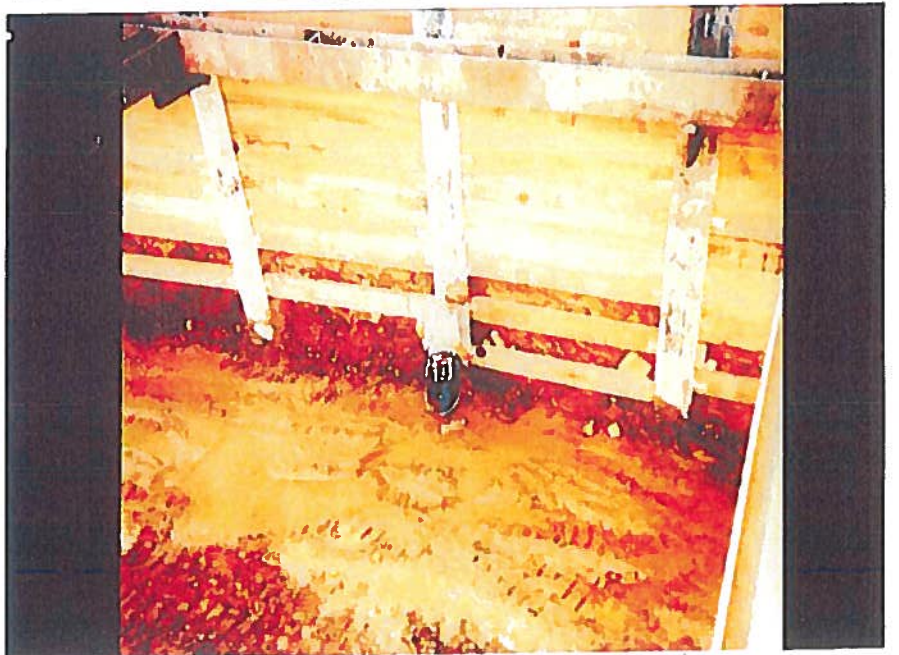
RUSTED METAL DEBRIS
EXCAVATED FROM SITE.

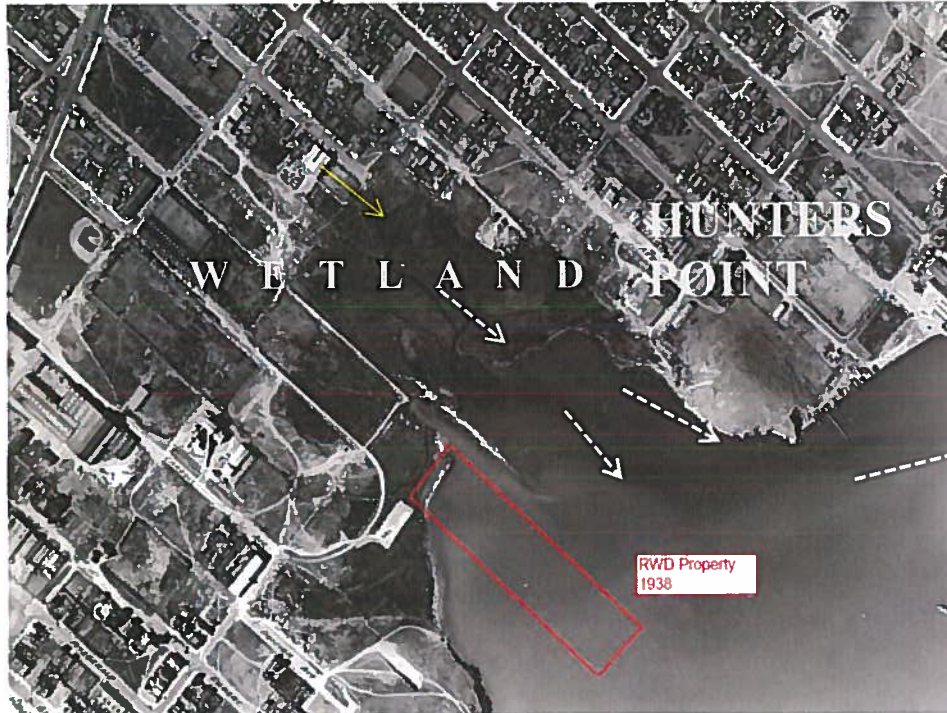
Inset Figure 3: 1938 Aerial Photograph

Northwest of the Subject Property is a larger wetland area near the former inlet (yellow arrow) of the Yosemite Creek/Slough, with a sandbar and evidence of urban discharge from stormwater sewers including suspended solids and possible oils (white dashed arrows). The shoreline area within ¼ mile of the Subject Property appears to be in a relatively native state, with no discernible evidence of recent fill encroaching on the San Francisco Bay.

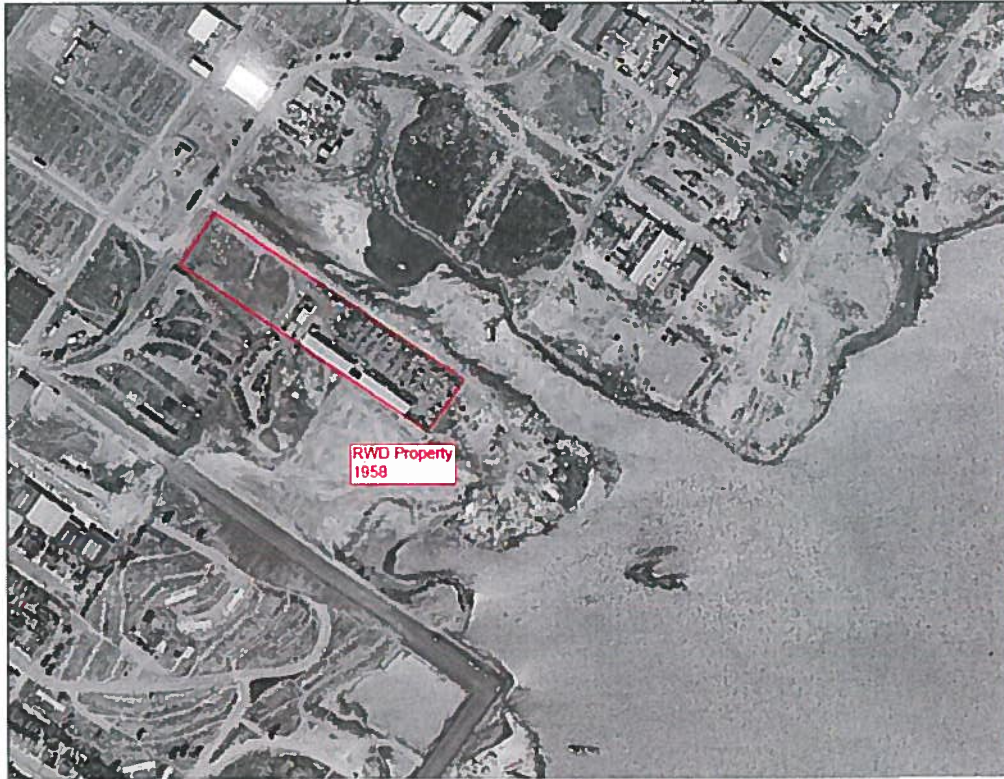
Inset Figure 7: 1958 Aerial Photograph

Inset Figure 7 (below) is an aerial photograph taken on July 22, 1958 (obtained from the National Archives) showing Subject Property use similar to the 1956 photo in Inset Figure 6. Inset Figure 7 shows that additional infill of the Bay was performed south and southwest of the Subject Property as part of the Candlestick Park construction project. Aerial photography indicates no additional fill placement occurred on the Subject Property after September 1956.
